# Kiwi Feather Props Ltd – LIMITED WARRANTY

# K4 - CUSTOMER MANUAL

**VERSION: 11.01.2021**

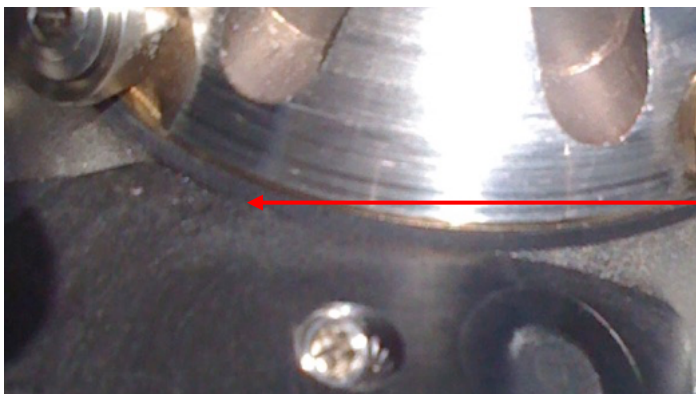
**This photo shows the rear of the blade aligned with the front of the aft seal which will equate to ~ 20 ° of pitch.**

**Increasing the pitch by screwing the pitch screw IN to align the blade surface with the rear edge of the seal will equate to ~ 23 °**

**One turn of the 8 mm pitch screw in a clockwise direction to each blade in turn will equate to 3 degrees of pitch** [not inches of pitch] and substantially increase the power required from the engine and drive train. This will translate to lower engine revs. We would recommend adjustments be made in no more than exact half turn increments to each blade, which has the effect of varying engine revs by some 200 ~ 300 rpm. Each installation is unique and only experience can deliver the appropriate settings and optimal cruising revs for your vessel. A pitch setting of 21 degrees on a 17" unit typically equates to a normal pitch of ~ 11 to 12 inches. [ The required Allen key is 5/32" or 4 mm ]

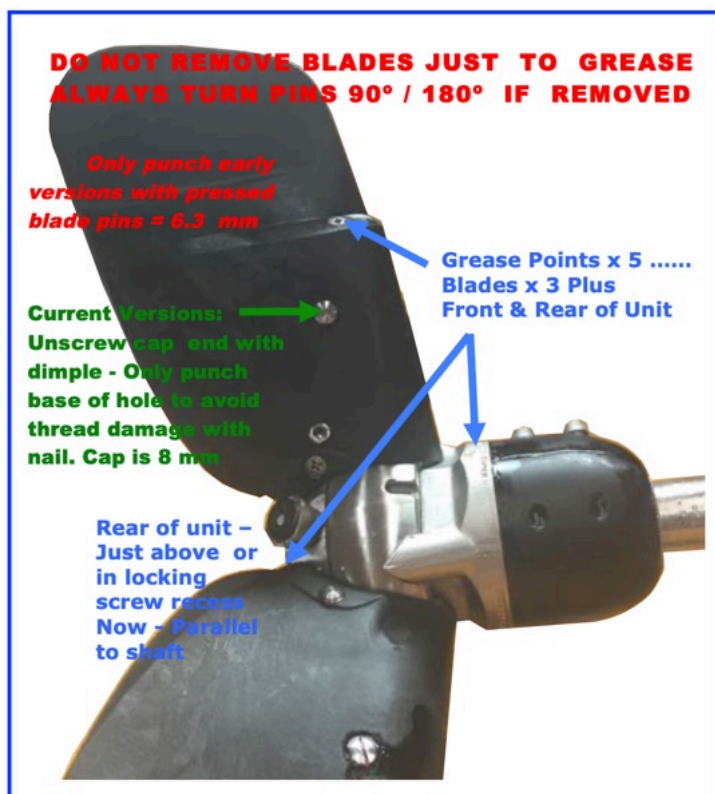
The *Kiwiprop*™ contains lubricants sufficient until your next maintenance haulout. Each blade must then be greased via a lubrication point accessed by removing the small Pozidrive stainless screw on the blade face. In addition, there are two small grease holes, one very close to the GF PP nose cone in the SS casting that takes the thrust of the pitch screws and one near the outer perimeter of the sphere at the rear of the unit inside one of the locking screw recess.

These have been chamfered to accept a standard needle nosed grease point that we provide with every unit.

Check the blade has been remounted on it's old pin. Now mount the retaining pin back into the reverse face of the blade from the side it came out of with a new wear face on the pin facing outwards. By tapping gently - reinsert the pin so that it is equidistant from each outer face of the blade. Refer photograph above for illustration.
