Kiwi Feather Props Ltd - LIMITED WARRANTY

Version Dated: 20.04.2011

CUSTOMER MANUAL

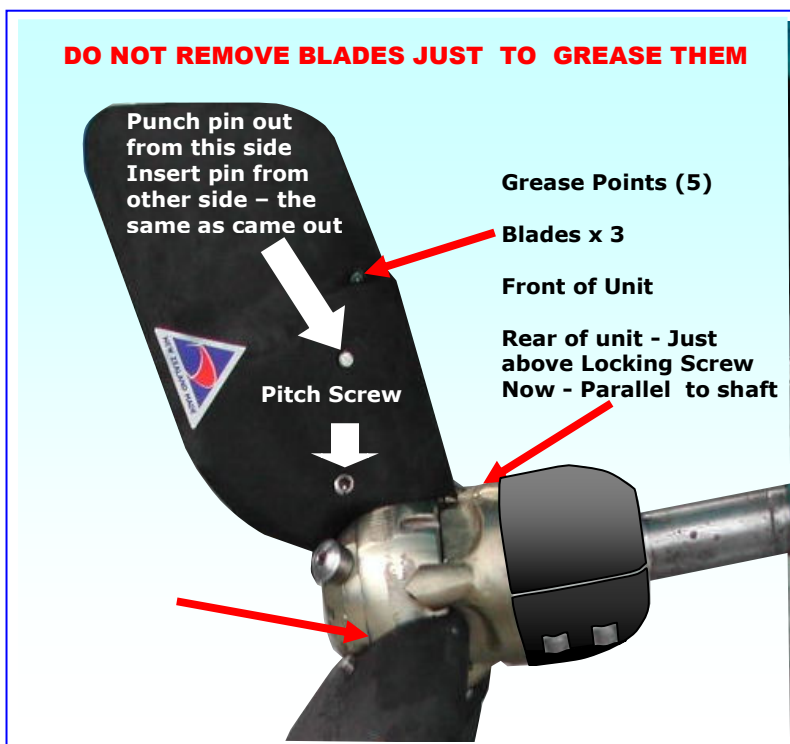
The *Kiwiprop™* contains lubricants sufficient until your next maintenance haulout. Each blade must then be greased via a lubrication point accessed by removing the small Pozidrive stainless screw on the blade face. In addition there are two small grease holes, one very close to the GF PP nose cone in the SS casting that takes the thrust of the pitch screws and one near the outer perimeter of the sphere at the rear of the unit inside the locking screw recess.

These have been chamfered to accept a standard needle nosed grease point that we provide with every unit.

Each of these five grease points should then be filled with a high quality marine grease: Grade - NLGI No 2 Mobilgrease XHP 222 for example

Check the reversing rollers are free to turn and free up if necessary

Check the blade has been remounted on it's old pin. Now mount the retaining pin back into the reverse face of the blade from the side it came out of with a new wear face on the pin facing outwards. By tapping gently - reinsert the pin so that it is equidistant from each outer face of the blade. Refer photograph above for illustration.
